CALIFORNIA DIVISION OF MINES AND GEOLOGY

FAULT EVALUATION REPORT FER-112

SUPPLEMENT NO. 1

1. Fault. Las Positas (south branch).
2. Field Observations.

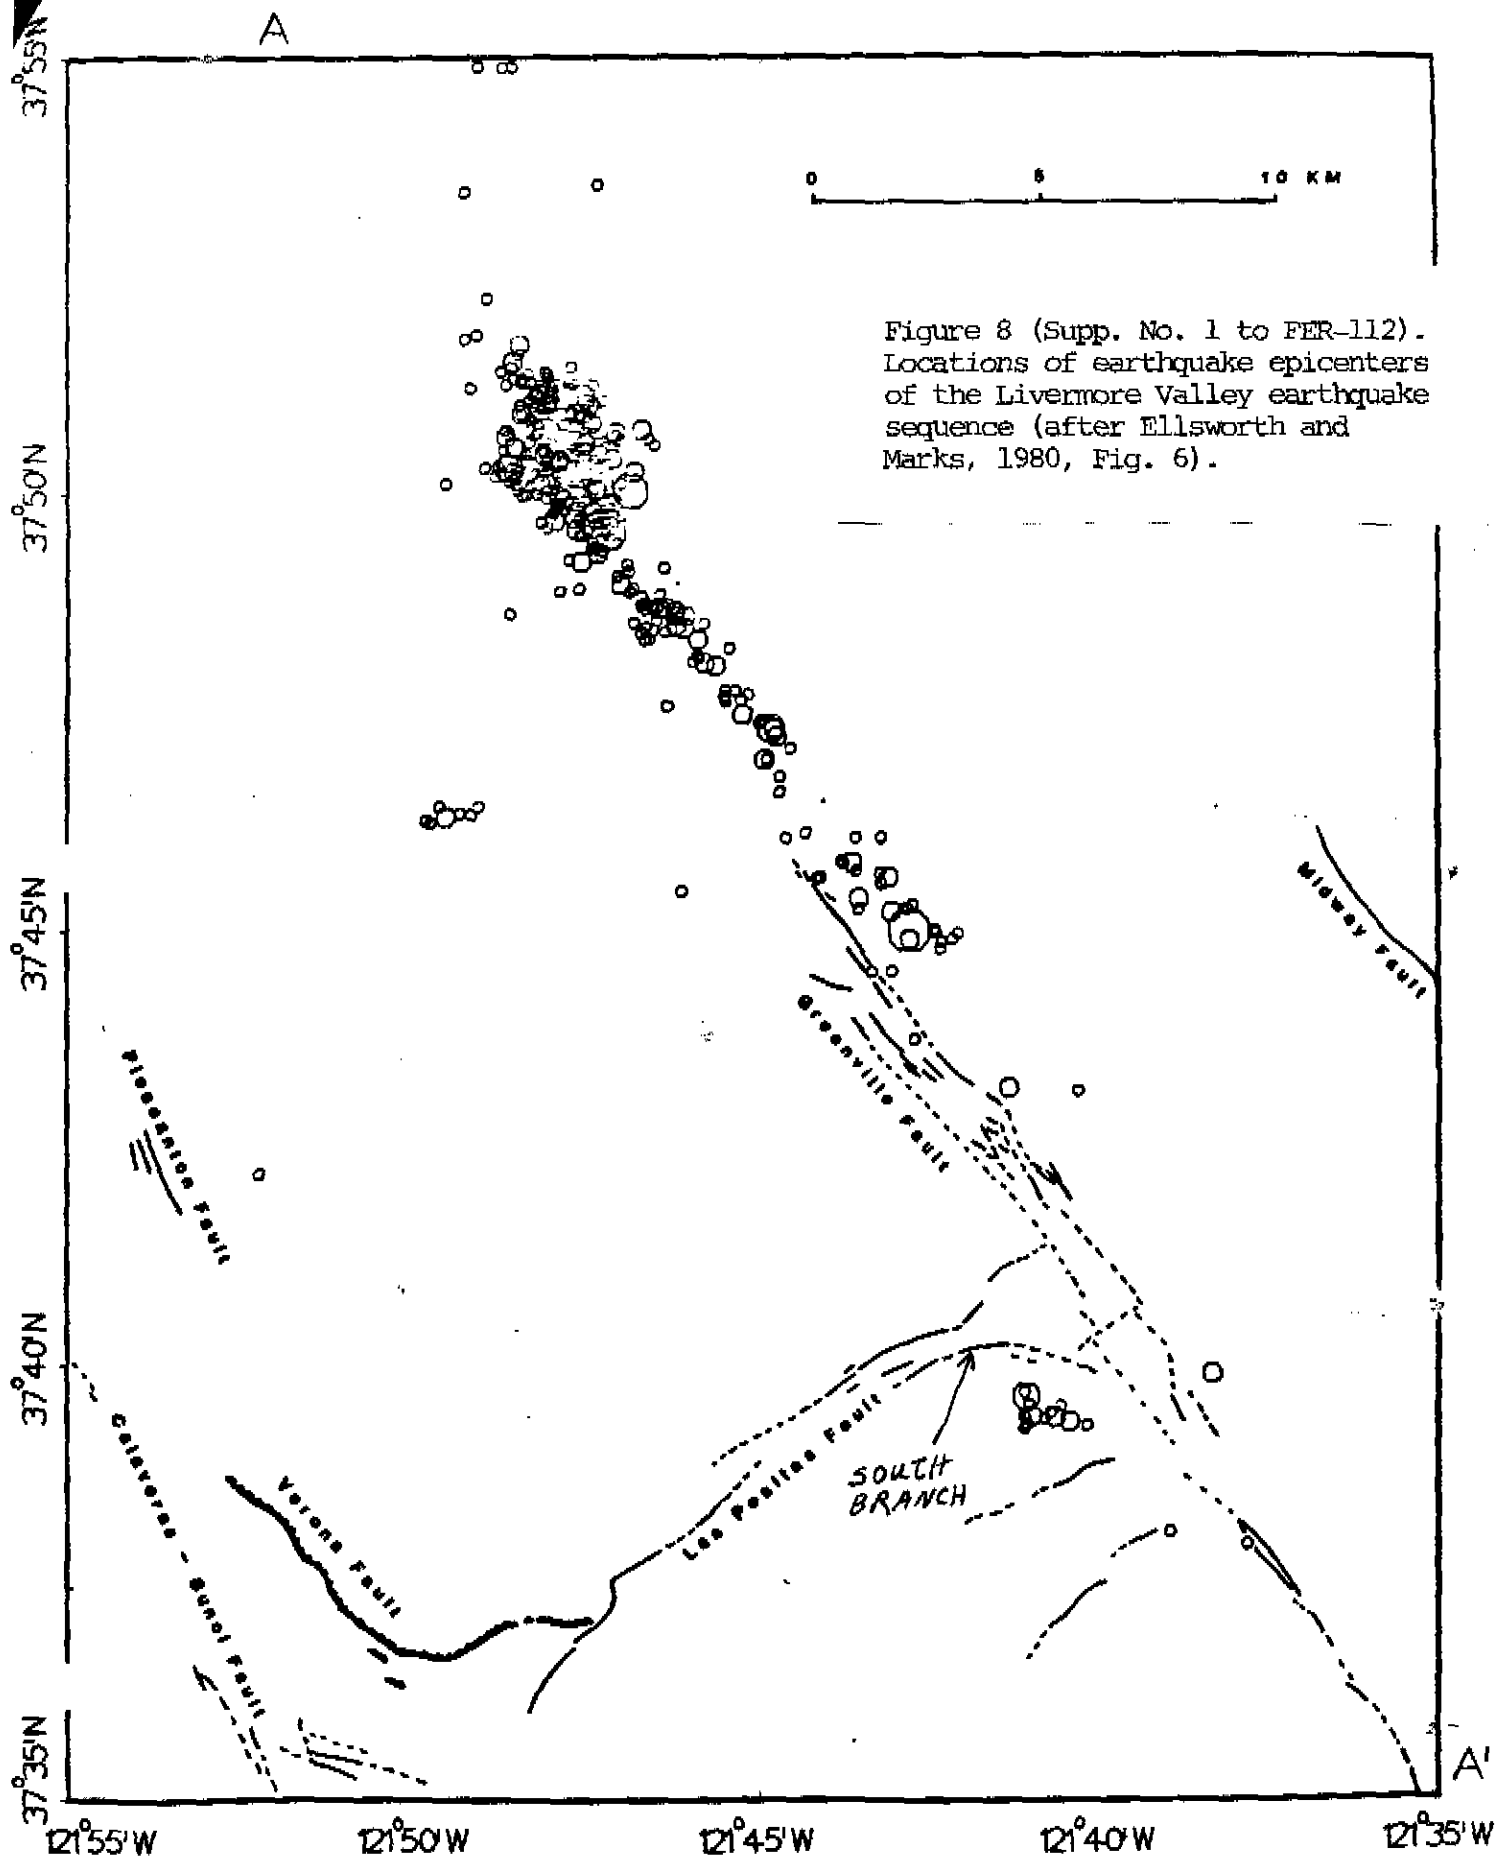
LIVERMORE VALLEY EARTHQUAKES

According to Ellsworth and Marks (1980), the south branch of the Las Positas fault lies just north of a cluster of earthquakes recorded during 1969 to 1979 (see Fig. 5 of FER-112) and the January 1980 Livermore Valley earthquake sequence (see Fig. 8, attached).

Based on these observations, and on the work of Herd and Smith, it appears likely that the south branch of the Las Positas fault is historically active. This is also suggested by recent seismicity just south of the fault. However, the observed cracks are very minor and could be due to causes other than tectonic faulting, (e.g., differential subsidence along an existing fault as a result of groundwater withdrawal).

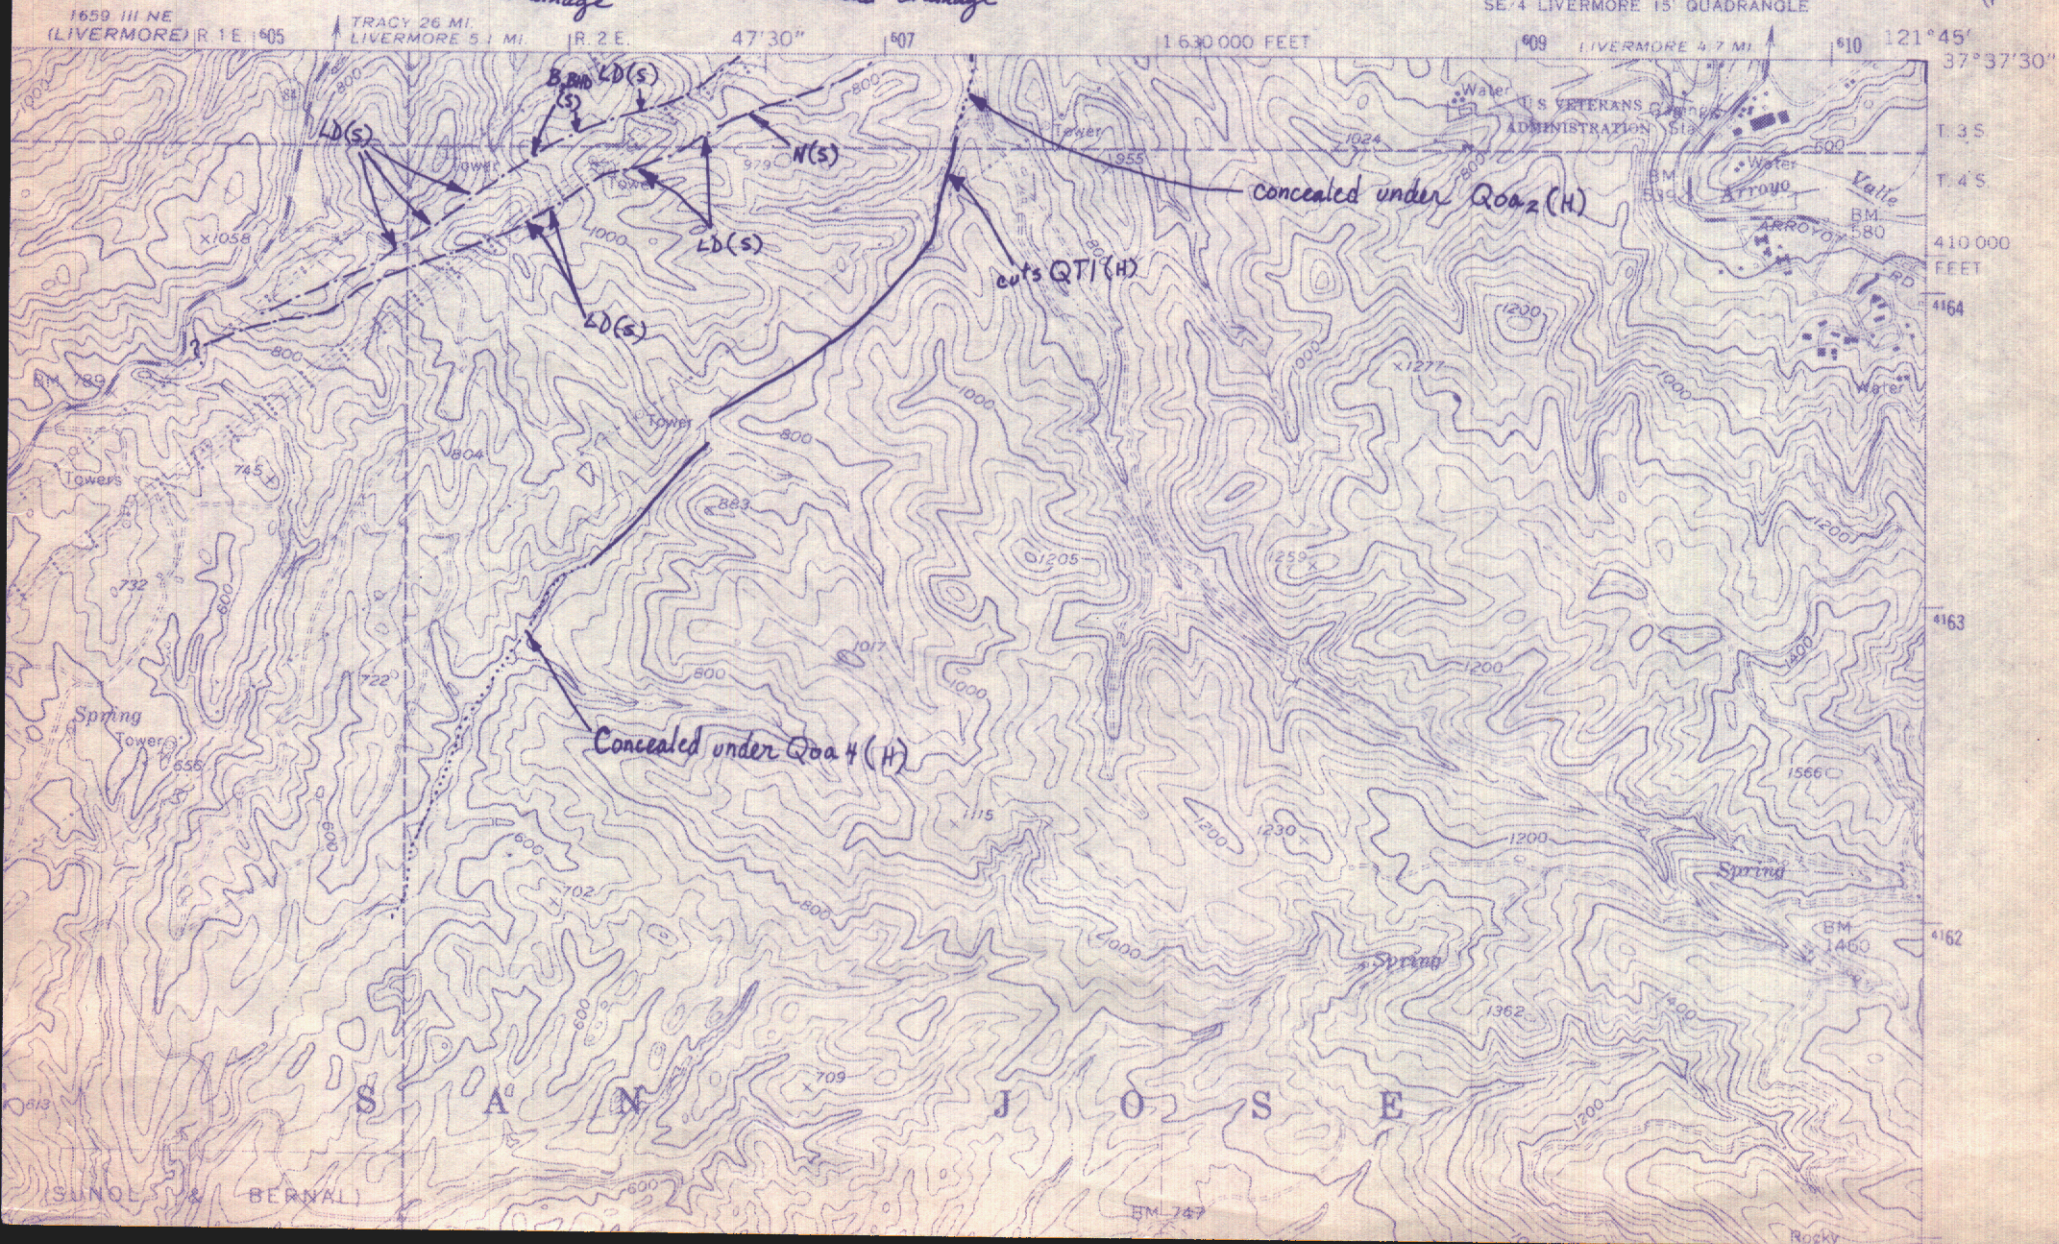
FER 112
Figure 3C. Air photo interpretation
(see Fig. 3A for explanation).

The crack zone and the exposed fault generally align with a south facing scarp (or break in slope) to the west of the road. This geomorphic feature was mapped by Darrel Herd (1977) and Theodore C. Smith (FER-112, Fig. 3A). No further observations were made by this writer.
